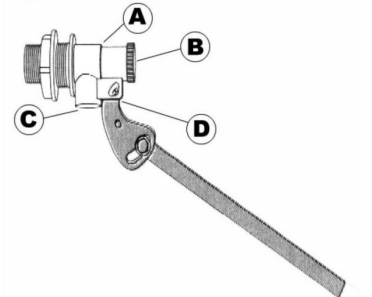
Fig. 1 – Art. 103

Art. 103 Fig. 1	Art. 106 Fig. 2	Art. 320 Fig. 3
No fractures on the body	A	A	A
Stopper well screwed up	B	B	
Tail pipe well screwed up (if included)	C	C <td C	
Regular and complete movement without obstacles of arm and piston	D	D	D

Art. 103 Fig. 1	Art. 106 Fig. 2	Art. 320 Fig. 3
Held test (airtight)

Arm down: air can flux

Arm up: air can't flux
